# SUSTAINABILITY AND EVALUATION OF THE IMPACT CAUSED BY THE LANDFILL OF THE MUNICIPALITY OF CARMEN, CAMPECHE, MÉXICO

Los indicadores de sustentabilidad permiten evaluar los impactos ambientales relacionados con la estrategia del desarrollo sustentable. Este estudio se realizó en Ciudad del Carmen, Campeche, que es considerada una isla de barrera que se localiza al sureste de México. El municipio canaliza la disposición final de los residuos sólidos urbanos (RSU) a través de un relleno sanitario el cual se encuentra ubicado en una zona de manglar, teniendo un impacto negativo en el medio ambiente lo que incide negativamente en el desarrollo sustentable. Mediante el análisis sedimentológico del subsuelo, se obtuvieron resultados que identificaron la dominancia de arenas carbonatadas, lo que permitió definir un rango de porosidad del 20,2 al 40,1 %, y permeabilidad de  $\pm 10^{-2}$ - $10^{-4}$  ms<sup>-1</sup> darcys, es decir, los sedimentos

The sustainability indicators allow the evaluation of the environmental impacts related to the sustainable development strategy. The research was conducted in ciudad del Carmen, Campeche, which is considered a barrier island located at the sou

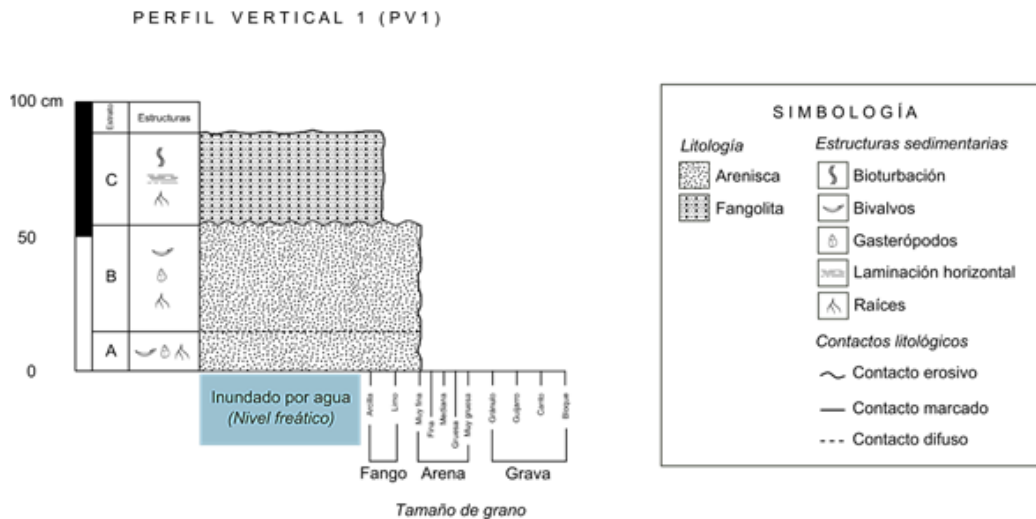
Figure 3. Lithological column of the VP1.

A lithological column with a thickness of 0.90 m.s.n.m. was identified, consisting of 3 strata. Granulometrically, sands of 0.125 to 0.062 mm composed of calcareous bigens and organic matter dominate the area. A porosity with a range of 20.2 to 30.2% was determined (Figure 3).

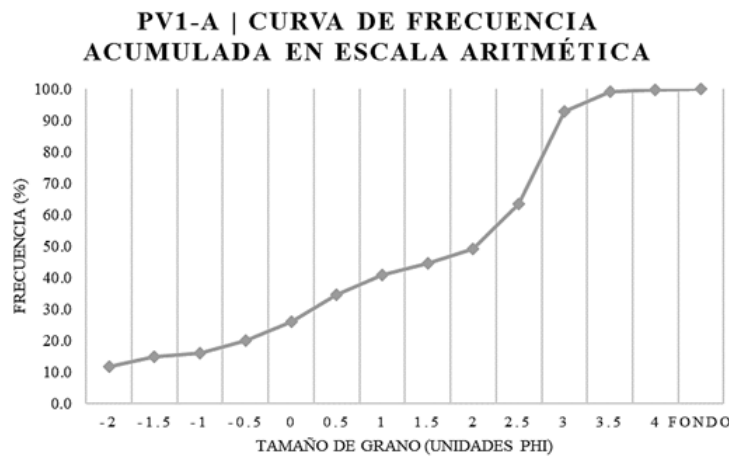
Figure 4. Curve of accumulated frequency in arithmetic scale of VP1-A

fine sand size ( $3.5 \phi$  to  $0.125 \text{ mm}$ ) (Figure 4). It belongs to the textural group Gravelly Sand, classified with the name of the sediment Fine Gravelly Fine Sand. Compositionally dominated by calcareous bigens and organic matter and with a porosity percentage of 20.2%.

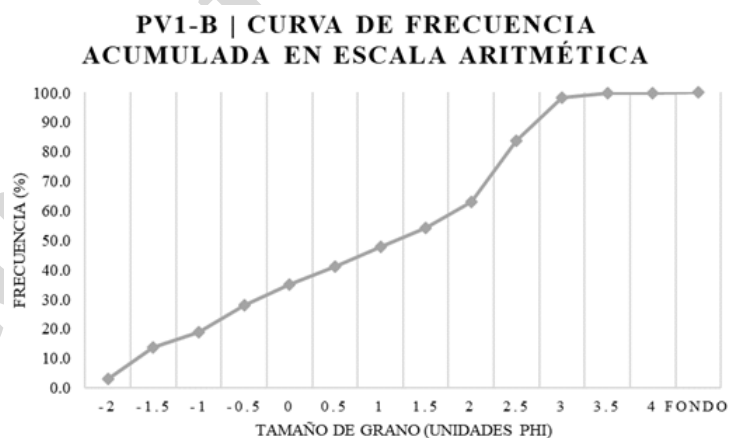
Figure 5. Curve of accumulated frequency in arithmetic scale of VP1-B

**Stratum B (VP1-B):** It is dominated by particles of fine-sized sands ( $2.5 \phi$  to  $0.25 \text{ mm}$ ) (Figure 5). It belongs to the Gravelly Sand textural group, classified as very Fine Gravelly Fine Sand sediment. Compositionally dominated by organic matter and quartz. It has a porosity percentage of 30.2%.

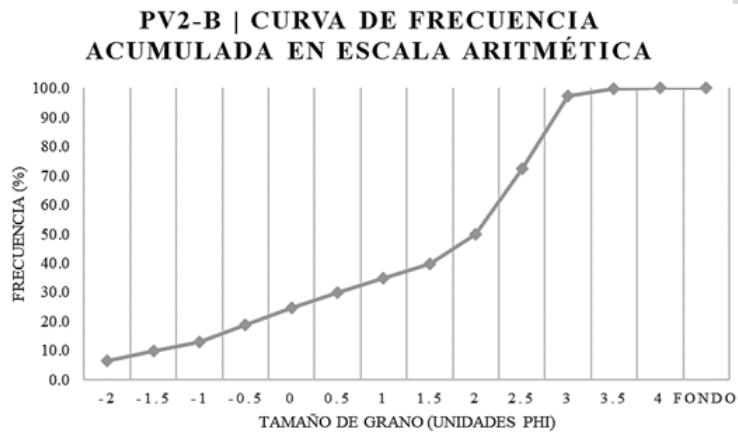
**Figure 8.** Curve of accumulated frequency in arithmetic scale of VP2-B

**Stratum B (VP2-B):** It is dominated by particles of very fine size to fine sands (3.5  $\phi$  to 0.25 mm) (Figure 8). It belongs to the textural group Gravelly Sand, classified with the name of the sediment Fine Gravelly Fine Sand. Compositionally, it is dominated by calcareous biogens and rock fragments. It has a porosity percentage of 36.5%.

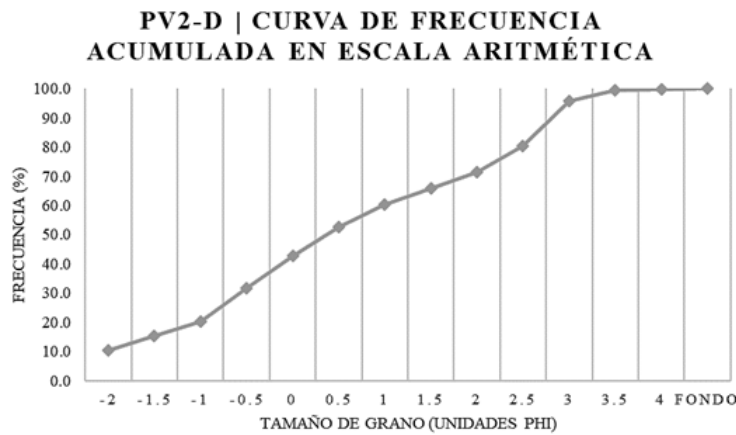
**Figure 9.** Curve of accumulated frequency in arithmetic scale of VP2-D

**Stratum D (VP2-D):** It is dominated by particles of very fine to very thick size sands (3.5  $\phi$  to 2 mm) (Figure 9). It belongs to the textural group Gravelly Sand, classified with the name of the sediment Fine Gravelly Fine Sand. Compositionally, it is dominated by calcareous biogens and rock fragments. It has

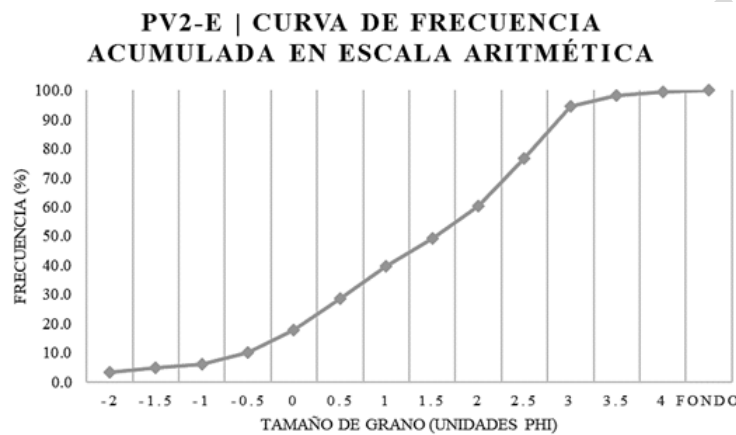
**Figure 10.** Curve of accumulated frequency in arithmetic scale of VP2-E

**Stratum E (VP2-E):** It is dominated by particles of very fine to fine size sands (3.5  $\phi$  to 0.25 mm) (Figure 10). It belongs to the textural group Gravelly Sand, classified with the name of the sediment Fine Gravelly Fine Sand. Compositionally, it is dominated by calcareous and calcite biogens. It has a porosity percentage of 29.7%.

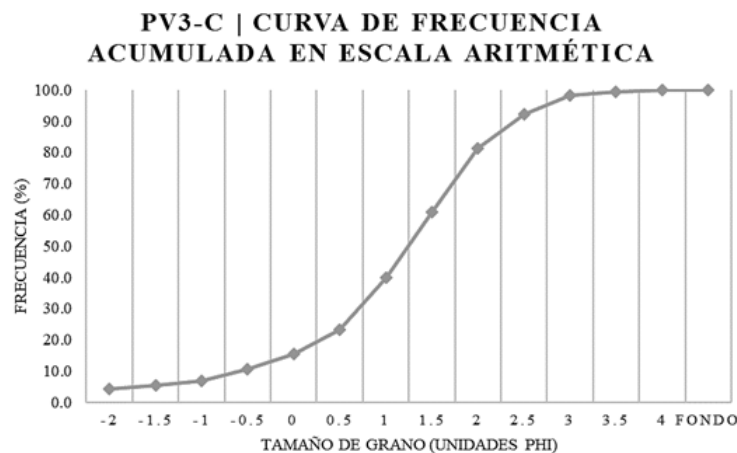
**Figure 14.** Curve of accumulated frequency in arithmetic scale of VP3-C

**Stratum C (VP3-C):** It is dominated by particles of very thick size sands to granules (1.4 to 4 mm) (Figure 14). It belongs to the sandy gravel textural group, classified with the sediment name Sandy Very Fine Gravel. Compositionally, it is dominated by calcareous bigens and rock fragments. It has a porosity percentage of 33.2 %.

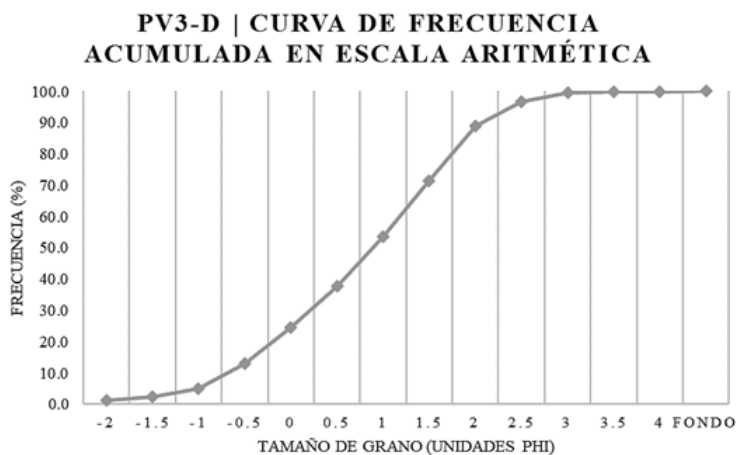
**Figure 15.** Curve of accumulated frequency in arithmetic scale of VP3-D

**Stratum D (VP3-D):** It is dominated by particles of fine to thick size sands (2.5 phi to 1 mm) (Figure 15).

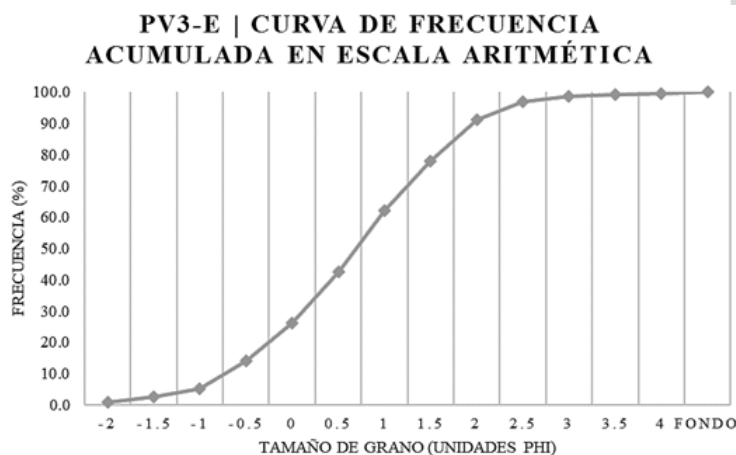
**Figure 16.** Curve of accumulated frequency in arithmetic scale of VP3-E

**Stratum E (VP3-E):** It is dominated by particles of medium to thick size sands (1.5  $\phi$  to 1 mm) (Figure 16). It belongs to the textural group Gravelly Sand, classified with the name of the very Fine Gravelly Coarse Sand sediment. Compositionally, it is dominated by calcareous bigens and organic matter. It has a porosity percentage of 40.1 %.
