# SUSTAINABILITY AND EVALUATION OF THE IMPACT CAUSED BY THE LANDFILL OF THE MUNICIPALITY OF CARMEN, CAMPECHE, MÉXICO

The sustainability indicators allow the evaluation of the environmental impacts related to the sustainable development strategy. The research was conducted in ciudad del Carmen, Campeche, which is considered a barrier island located at the southeast of Mexico. The municipality channels the final disposal of solid urban waste (MSW) through a sanitary landfill which is located in a mangrove area, having a negative impact on the environment, negatively affects the sustainable development. This research identified a sequence of carbonated sands by means of subsoil sediment analysis, which allowed to define a porosity of 20.2 to 40.1% and a permeability of  $\pm 10^{-2}$ - $10^{-4} \text{ ms}^{-1}$ , i.e., the sediments have good porous and high permeability. On the other hand, and with respect to water quality, concentrations of  $BOD_5$  and COD in the mangrove were 63.06 and 1338.13  $\text{mg L}^{-1}$ , respectively, as well as the presence of trace concentrations of some heavy metals. These values allowed to classify it as a strongly contaminated body of water.

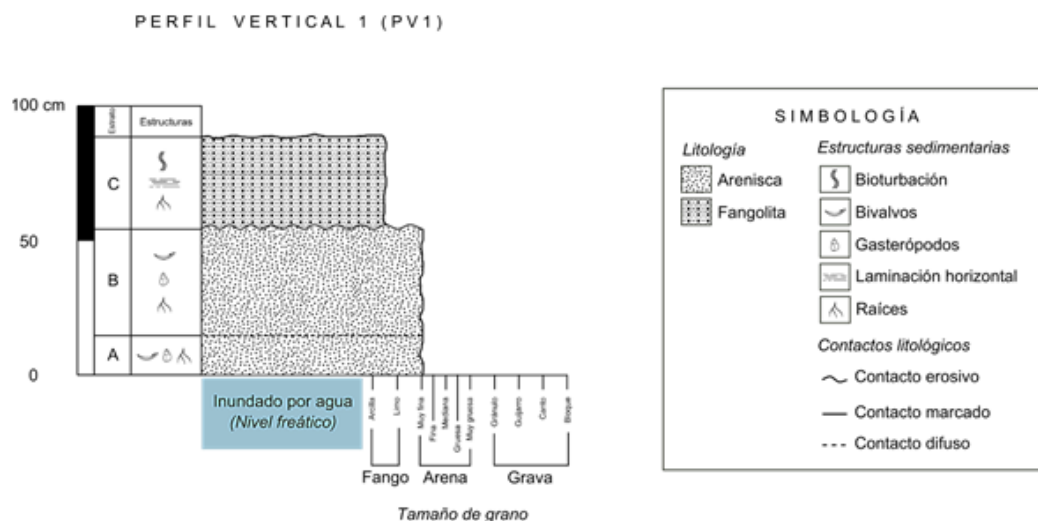
Figure 3. Lithological column of the VP1.

A lithological column with a thickness of 0.90 m.s.n.m. was identified, consisting of 3 strata. Granulometrically, sands of 0.125 to 0.062 mm composed of calcareous bigens and organic matter dominate the area. A porosity with a range of 20.2 to 30.2% was determined (Figure 3).

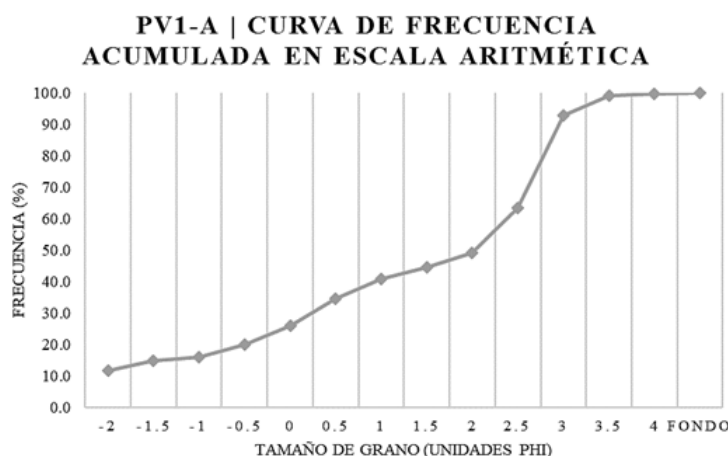
Figure 4. Curve of accumulated frequency in arithmetic scale of VP1-A

fine sand size ( $3.5 \phi$  to  $0.125 \text{ mm}$ ) (Figure 4). It belongs to the textural group Gravelly Sand, classified with the name of the sediment Fine Gravelly Fine Sand. Compositionally dominated by calcareous bigens and organic matter and with a porosity percentage of 20.2%.

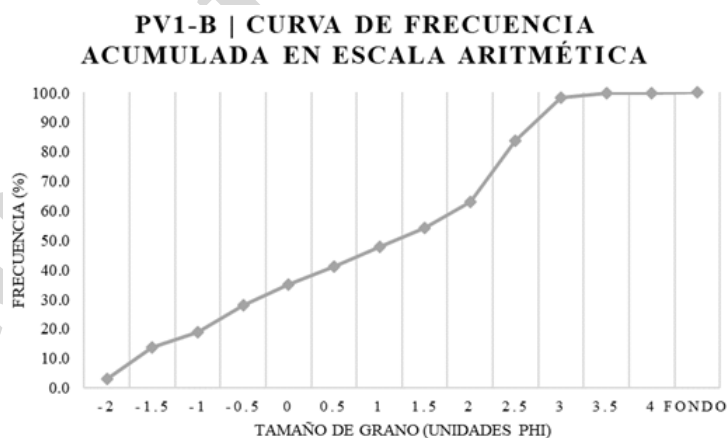
Figure 5. Curve of accumulated frequency in arithmetic scale of VP1-B

**Stratum B (VP1-B):** It is dominated by particles of fine-sized sands ( $2.5 \phi$  to  $0.25 \text{ mm}$ ) (Figure 5). It belongs to the Gravelly Sand textural group, classified as very Fine Gravelly Fine Sand sediment. Compositionally dominated by organic matter and quartz. It has a porosity percentage of 30.2%.

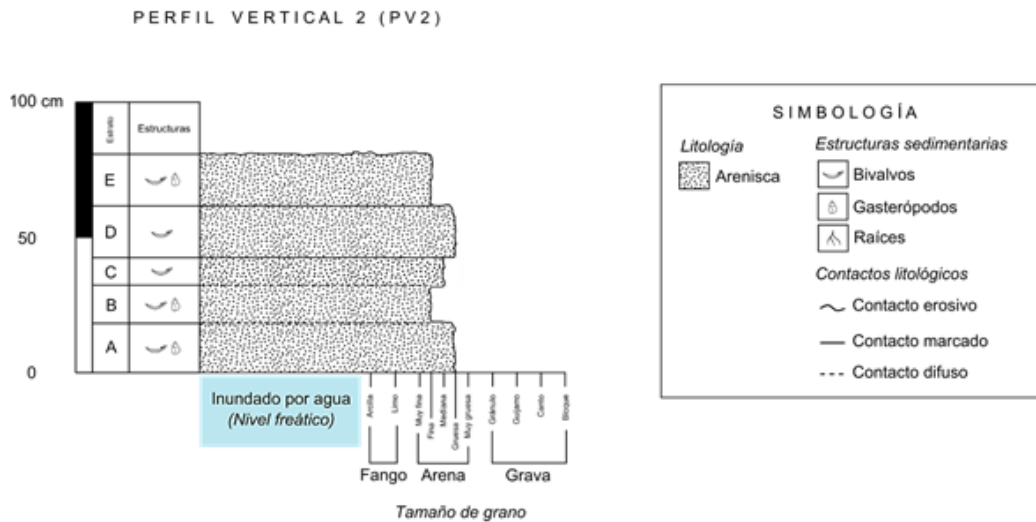
**Figure 6.** Lithological column of VP2

It was identified as a lithological column with a thickness of 0.83 m.a.s.l, consisting of 5 strata. Granulometrically, sands of 1 to 0.125 mm composed of calcareous biogens and dethyritic material dominate the area. A porosity with a range of 20.3 to 36.5% was determined (Figure 6).

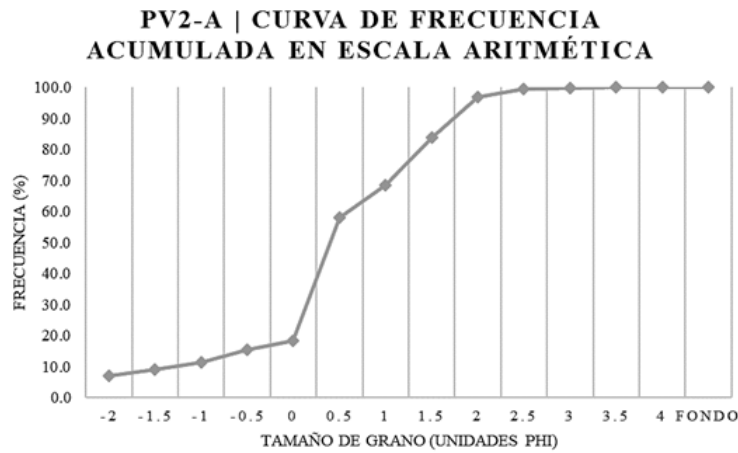
**Figure 7.** Curve of accumulated frequency in arithmetic scale of VP2-A

**Stratum A (VP2-A):** It is dominated by particles thick-size sands (0.5  $\phi$  to 1 mm) (Figure 7). It belongs to the textural group Gravelly Sand, classified with the name of the sediment Fine Gravelly Coarse Sand. Compositionally, it is dominated by calcareous biogens and quartz. It has a porosity percentage of 20.3%.

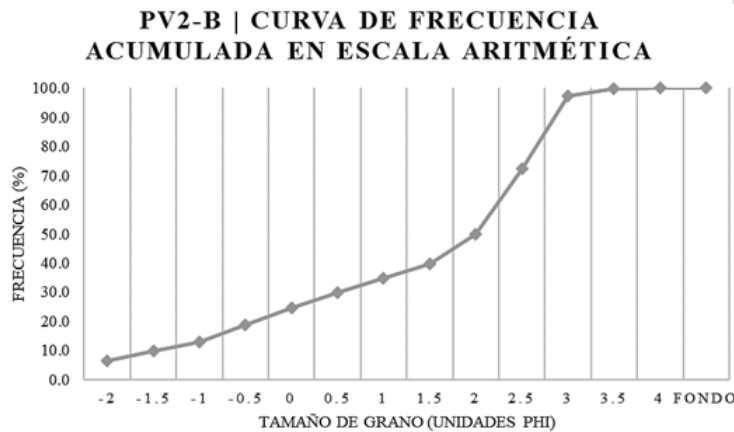
**Figure 8.** Curve of accumulated frequency in arithmetic scale of VP2-B

**Stratum B (VP2-B):** It is dominated by particles of very fine size to fine sands (3.5  $\phi$  to 0.25 mm) (Figure 8). It belongs to the textural group Gravelly Sand, classified with the name of the sediment Fine Gravelly Fine Sand. Compositionally, it is dominated by calcareous biogens and rock fragments. It has a porosity percentage of 36.5%.

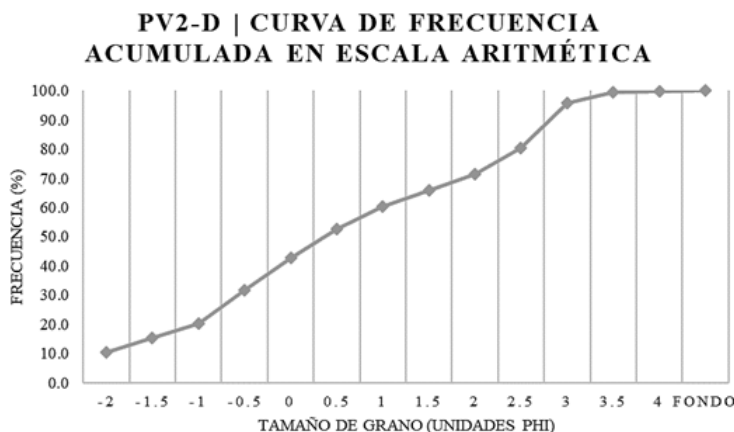
**Figure 9.** Curve of accumulated frequency in arithmetic scale of VP2-D

**Stratum D (VP2-D):** It is dominated by particles of very fine to very thick size sands (3.5  $\phi$  to 2 mm) (Figure 9). It belongs to the textural group Gravelly Sand, classified with the name of the sediment Fine Gravelly Fine Sand. Compositionally, it is dominated by calcareous biogens and rock fragments. It has

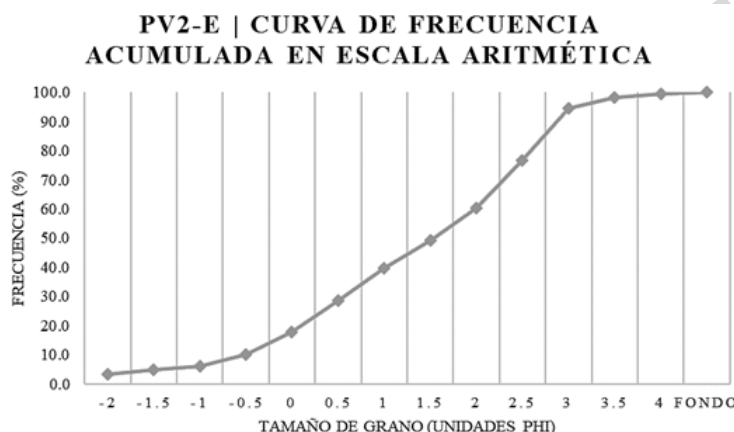
**Figure 10.** Curve of accumulated frequency in arithmetic scale of VP2-E

**Stratum E (VP2-E):** It is dominated by particles of very fine to fine size sands (3.5  $\phi$  to 0.25 mm) (Figure 10). It belongs to the textural group Gravelly Sand, classified with the name of the sediment Fine Gravelly Fine Sand. Compositionally, it is dominated by calcareous and calcite biogens. It has a porosity percentage of 29.7%.

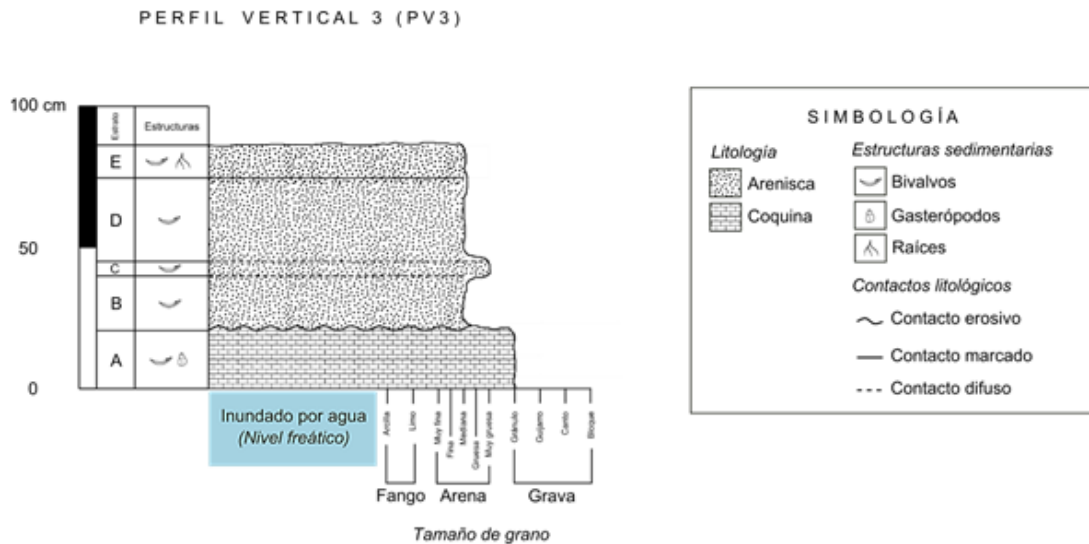
Figure 11. Lithological column of VP3

A lithological column with a thickness of 0.88 m.a.s.l was identified consisting of 5 strata. Granulometrically, gravel and sands from 4 mm to 0.25 mm dominate, composed of calcareous biogens and dethyritic material. A porosity with a range of 26.1 to 40.1% was determined (Figure 11).

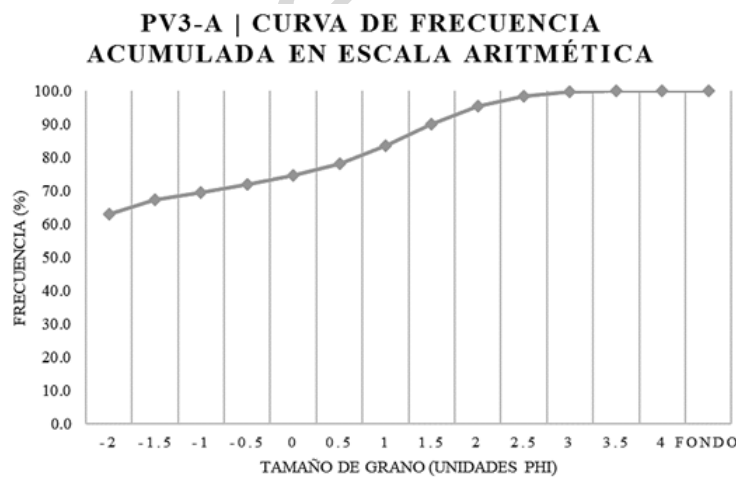
Figure 12. Curve of accumulated frequency in arithmetic scale of VP3-A

**Stratum A (VP3-A):** It is dominated by granule-sized particles (2.8 to 4 mm) (Figure 12). It belongs to the sandy gravel textural group, classified with the sediment name Sandy Fine Gravel. Compositionally, it is dominated by calcareous biogens and rock fragments. It has a porosity percentage of 36.8%.

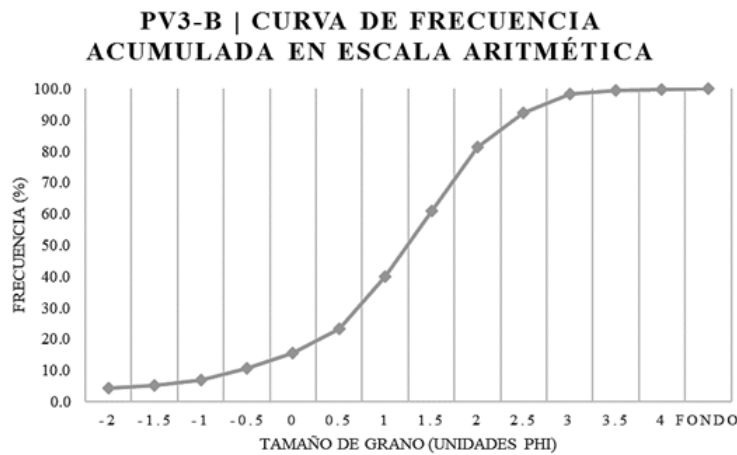
**Figure 13.** Curve of accumulated frequency in arithmetic scale of VP3-B

**Stratum B (VP3-B):** It is dominated by particles of fine to medium size sands (2.5  $\phi$  to 0.5 mm) (Figure 13). It belongs to the gravelly Sand textural group, classified with the name fine Gravelly Medium Sand. Compositionally, it is dominated by

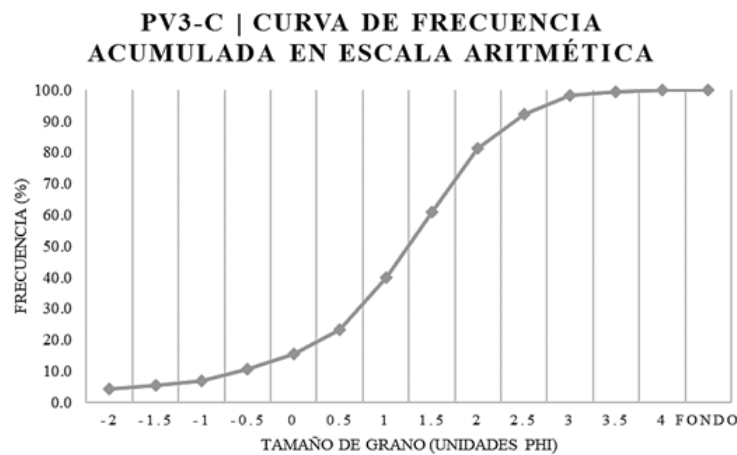
**Figure 14.** Curve of accumulated frequency in arithmetic scale of VP3-C

**Stratum C (VP3-C):** It is dominated by particles of very thick size sands to granules (1.4 to 4 mm) (Figure 14). It belongs to the sandy gravel textural group, classified with the sediment name Sandy Very Fine Gravel. Compositionally, it is dominated by calcareous bigens and rock fragments. It has a porosity percentage of 33.2 %.

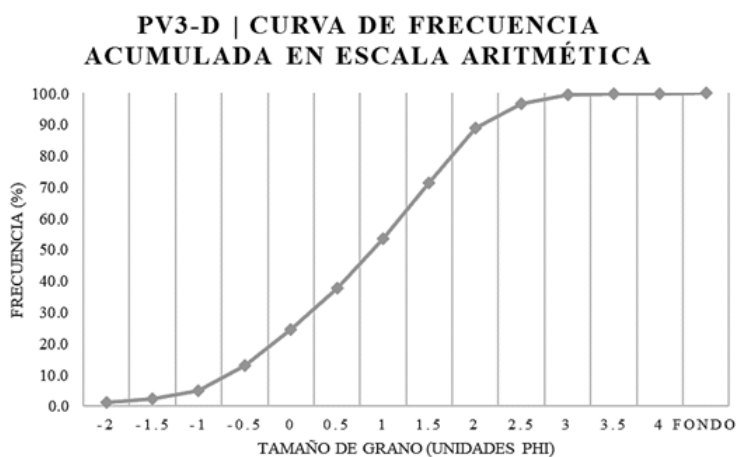
**Figure 15.** Curve of accumulated frequency in arithmetic scale of VP3-D

**Stratum D (VP3-D):** It is dominated by particles of fine to thick size sands (2.5 phi to 1 mm) (Figure 15).

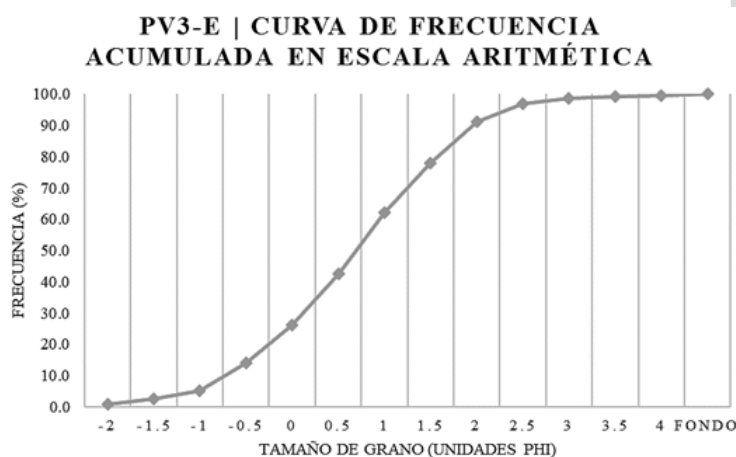
**Figure 16.** Curve of accumulated frequency in arithmetic scale of VP3-E

**Stratum E (VP3-E):** It is dominated by particles of medium to thick size sands (1.5  $\phi$  to 1 mm) (Figure 16). It belongs to the textural group Gravelly Sand, classified with the name of the very Fine Gravelly Coarse Sand sediment. Compositionally, it is dominated by calcareous bigens and organic matter. It has a porosity percentage of 40.1 %.

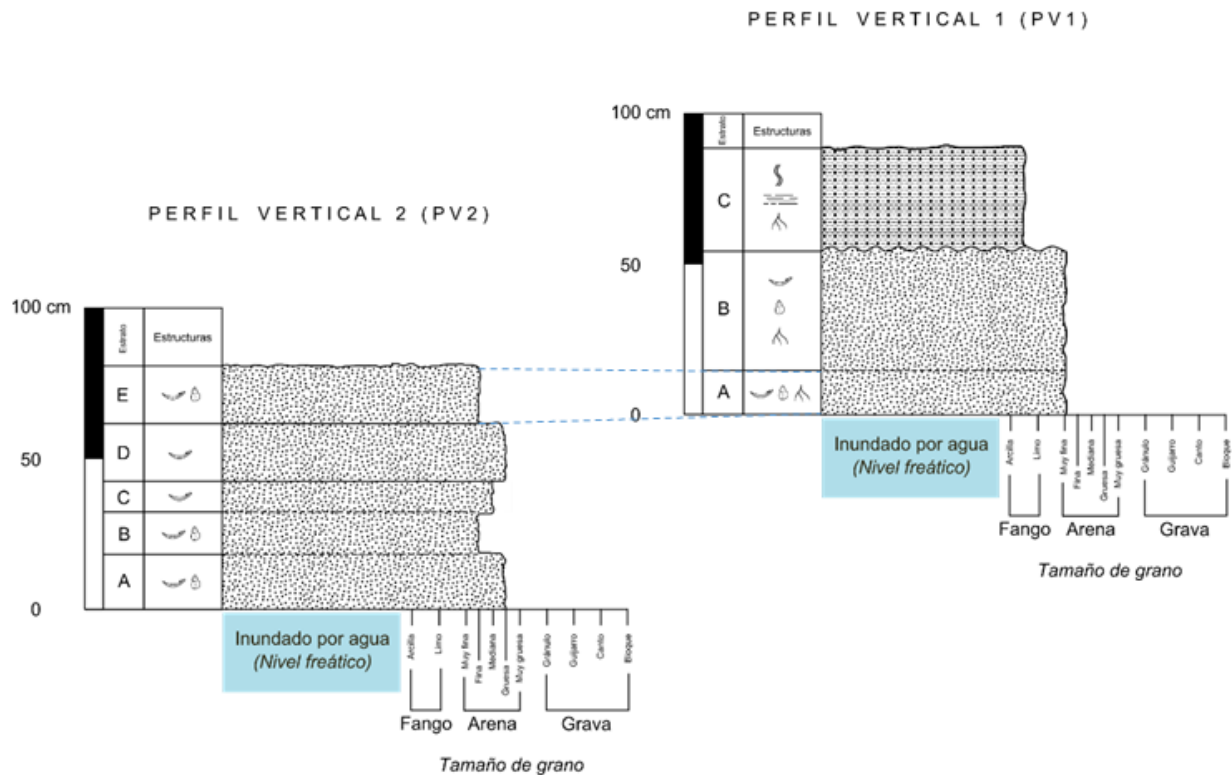
**Figure 17.** Stratigraphic correlation of VP1-a with VP2-E

ponents (calcareous biogens and rock fragments), thus a lateral continuity of the strata was determined. Meanwhile, the first stratum (VP2-A) of VP2 with the last stratum (VP1-B) of VP1, bears a similarity in granulometry (2.5  $\phi$ ), sedimentary components (calcareous biogens, organic matter and quartz) and correspondence in topographical elevation, which allowed them to be stratigraphically

correlated (Figure 17).

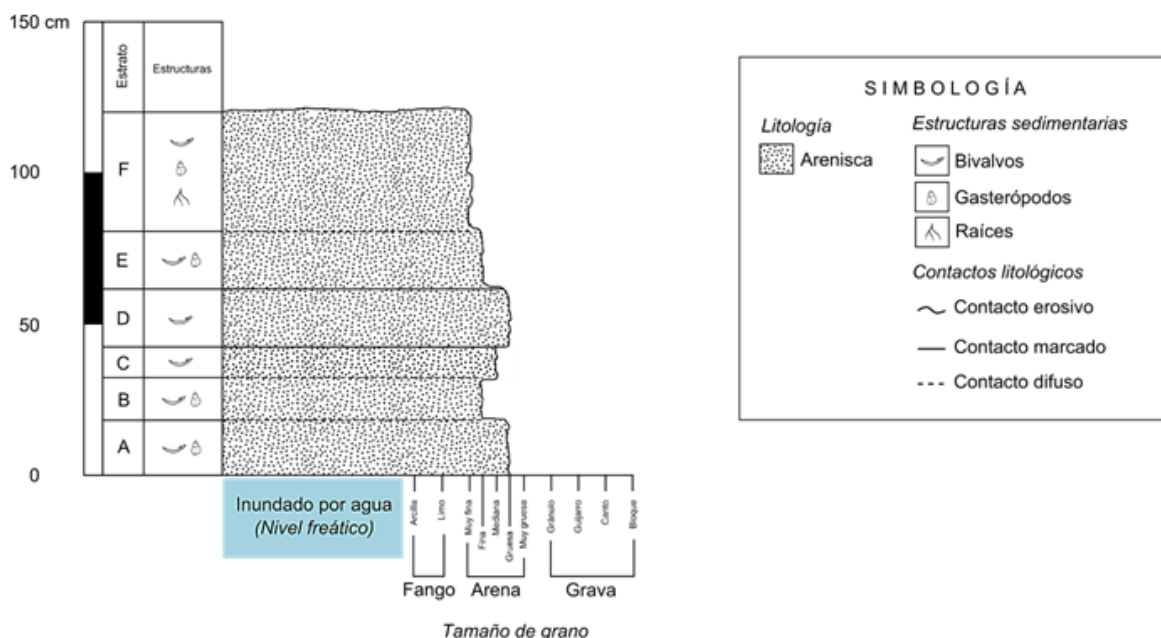
Figure 18. Lithological column of the study area

Thus, it was determined that the study area is formed by a lithological column consisting of six main strata, granulometrically dominated by sands of sizes 0.062 to 4 mm, composed of calcareous biogens and earthy material (Figure 18). According to Magallanes-Ordóñez et al. (2015), the sands could come from the sea; and the clays are from the adjacent continent.
